BELZONA REPAIRS DAMAGED FLOOR IN A WAREHOUSE

Cement plant in Croatia

February 2014

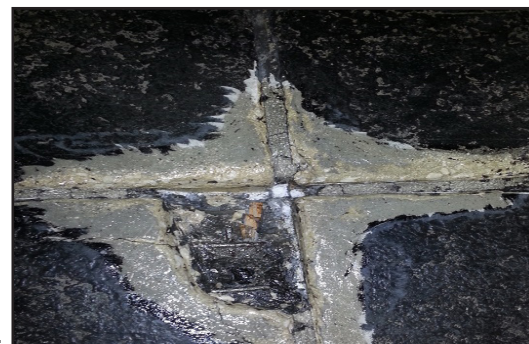
Concrete floor of a warehouse in a cement plant was damaged due to heavy traffic of forklifts and trucks, as well as storage of palettes with cement over time. The damage was situated on joint areas of large concrete plates (3m x 5m) of the floor.

1. A damaged concrete floor in a warehouse.
2. Damaged area rebuilt with Belzona 4111.
3. Sealing expansion joints with Belzona 4521.
4. Situation after 1 year.

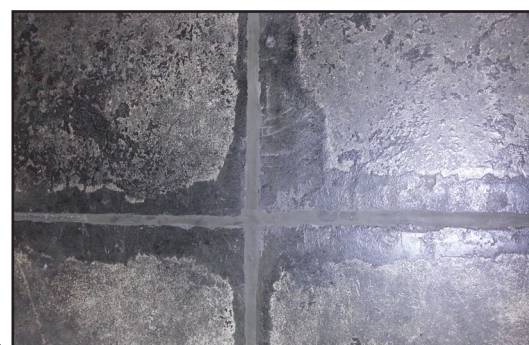
4.

Because of continuous 24/7 production, the warehouse must be in use all the time and only small portion of it could be out of use. According to customer, Belzona offered the best value for money, allowing the customer's staff to do repairs themselves in periods with less activity in the warehouse. Site revisited after 1 year shows that repaired area is still in perfect shape.
