## BELZONA REPAIRS VOITH SCHNEIDER UNIT

A Voith Schneider propulsion unit was experiencing erosion/corrosion from sand/silt & sea water in service.

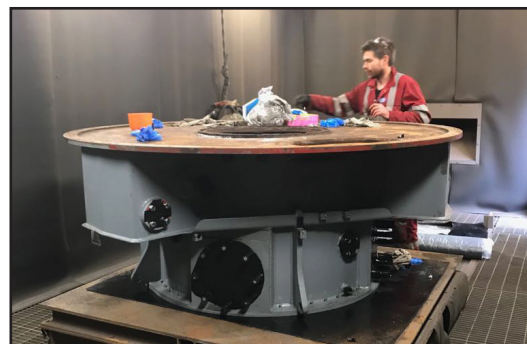
1. Voith unit in blast booth
2. Close up of metal loss
3. Sealing face built up
4. Machining of product

The face of the unit was first grit blasted to SA2.5 & 75 microns. The face of the casing was then built up with Belzona 1311 before being overcoated with Belzona 1321. The inner bore was a sealing face, it was built up with Belzona 1311 & then machined down to a close tolerance.

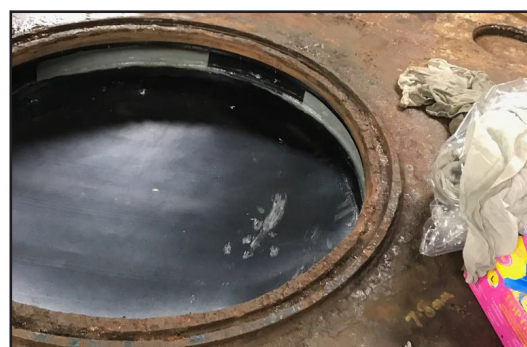
2.

Erosion/corrosion damage meant the unit no longer functioned correctly. Replacement of the unit would total around £120,000
