## POTABLE WATER TANK REPAIRED WITH BELZONA COMPOSITE PATCH STANDS THE TEST OF TIME

A hairline crack/leak developed on an HDLPE potable water tank on a major deepwater drilling/production platform.

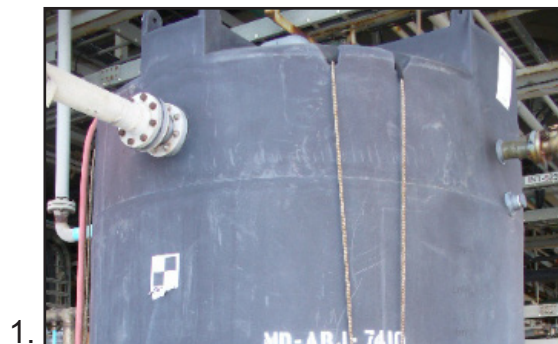
1. Potable water tank overview
2. Location of the leak (a tiny wisp of water pushing out)
3. Belzona composite patch repair completed
4. Belzona composite patch repair holding 1 year later

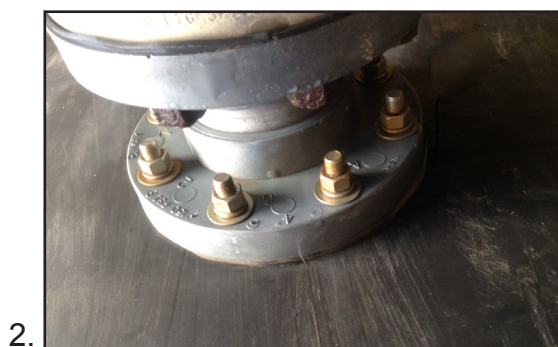
UV Damage and possible loading forces to the HDLPE polymer tank resulted in a hairline crack above a 4" flange. Replacement of the tank was several years away still and the repair method had to be compliant with potable water standards.

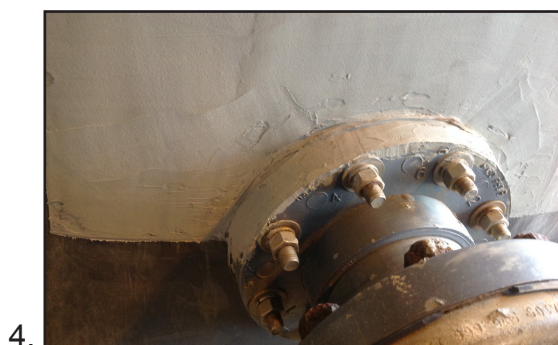
This application is still holding well over a year later, saving this platform from having to complete a costly replacement prior to the scheduled outage. This repair method has become a standard and they keep contingency repair kits on board at all times.
