BELZONA SAVED HAWSE HOLES OF A FISH PROCESSING VESSEL

Hawse hole on a 225' fish processing ship.

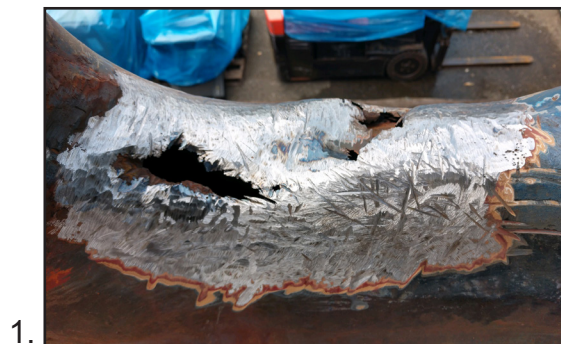
While the ship was at a shipyard, someone used a steel cable to secure the ship to the dock. The motion of the sea caused the steel cable to work back and forth like a saw and caused heavy damage to two of the hawse holes, one considerably worse than the other. Usually, a 3" rope is used to secure the boat, but after the damage had been done, there were sharp edges that would have frayed or even cut a rope had it been placed through the hawse hole. This presents a major problem since while the ship is processing salmon in Alaska, it must get tied up, and this could cause the ship to break loose during a bad Alaskan storm.

1. Original damage to the Hawse hole.
2. Belzona 1311 is applied.
3. Hawse hole repair complete.
4. Hawse hole repair complete.
