## BELZONA PROTECTS STEEL JOINTS ON LARGE SUSPENSION BRIDGE

Structural steel joints on a suspension bridge exposed to weathering and moisture, especially with the river flowing directly beneath.

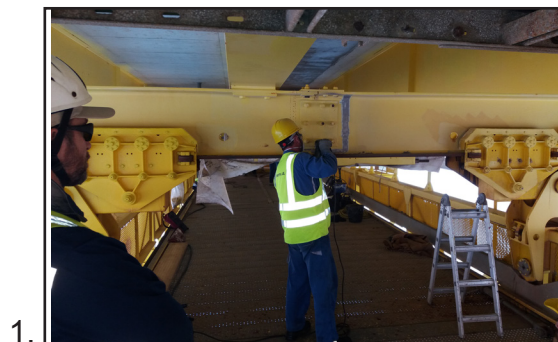
Corrosion in the bolt areas of the steel joints caused by insufficient protection from the existing paint. Due to the movement in the joints, the customer required a flexible coating. They wanted a system that would allow them to later inspect the bolts.

1. Preparation being carried out
2. Preparation completed
3. First coat of Belzona 3412 applied
4. Completed application

Application was carried out in accordance with an amended version of System Leaflet GSS-11.
