BELZONA REPAIRS PITTED ENGINE CYLINDERS

Shipyard, Glasgow, Scotland

An engine block for a tugboat was found to have pitting around the cylinders.

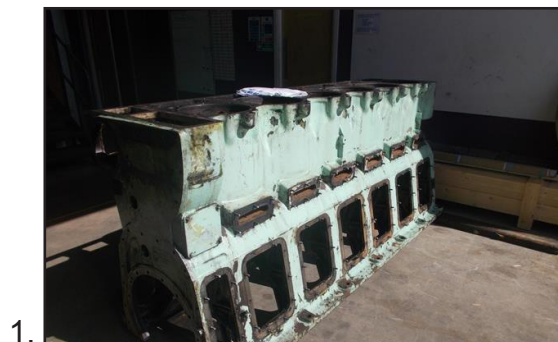
1. The Engine block
2. Close up of pitting damage
3. Areas after grit blasting
4. Application of Belzona 1111
