BELZONA HELPS REBUILD END COOLER HEADERS

End cooler headers of a tube sheet. Design temperature: 200F

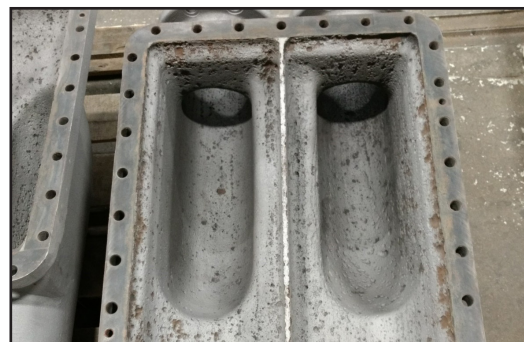
Severe pitting, corrosion appeared on the covers after years of operation. The worst of the pitting was about 8mm deep.

1. Internal surface before application
2. Internal surface showing severe pitting & corrosion damage
3. Belzona 1511 application, the product is being applied
4. Completed application
