BELZONA SUPPORTS EFFLUENT TANK

Damaged concrete supports of effluent water vessel

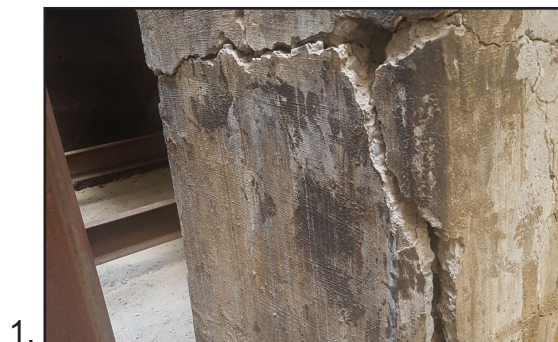
Water ingress and weathering had caused corrosion of the reinforcement bar, leading to cracking and spalling of the concrete supports.

1. Cracked and Spalling Concrete.
2. Damaged and loosely adhered concrete removed Images.
3. Concrete supports repaired and coated.

Damaged and loose concrete was removed before the surface was abraded using mechanical tools to clean and roughen the surface, and remove corrosion from the reinforcement bar. Compressed air was then used to remove dust. The surface was primed with Belzona 4911, and Belzona 4141 used to rebuild the surface to the original dimensions. For additional protection from weathering and potential spillage from the tank, 2 coats of Belzona 5811 were added to protect the vessel supports.
