FAST REPAIR OF BUTTERFLY VALVES WITH BELZONA ELASTOMERS RETURNS VESSEL TO SERVICE ON TIME

Two butterfly valves that control the flow of seawater in a vessel. The valves needed to be repaired to return the vessel to water on time.

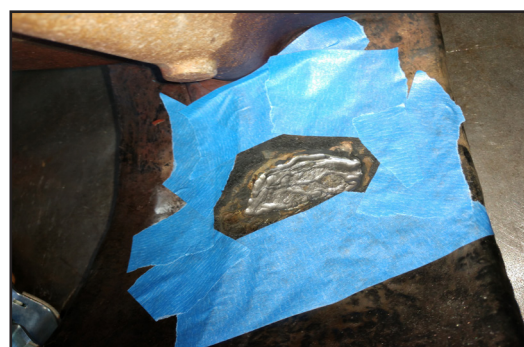
Two valves were damaged as the rubber boot that provided the sealing surface had suffered damage. One appeared to be damaged by debris that was in the way while the valve was closed removing a large piece of rubber material. The other valve was damaged at the seating area probably during installation.

1. The Customer was excited to use Belzona to complete the repair.
2. Valve 1 with a large piece of rubber boot missing after surface preparation.
3. Valve 2 with damage on the seating area after surface preparation.
4. Repaired valves.

A modified version of Belzona System Leaflet VPF-3 was used to repair the valve lining. Loose material was removed and rubber substrate was undercut to avoid a feathered edge. Application area was thoroughly degreased to remove contamination. Steel substrate was ground and rubber substrate was abraded with roughening brush to create a surface profile for Belzona 2121 (an ABS approved product) to achieve a mechanical bond. The surface was then conditioned with a light coat of Belzona 2911 and allowed to cure. The areas of concern were then masked off and then Belzona 2121 was poured into place. The masking tape was removed immediately and the product was left to cure. After the product had cured the repair areas were machined back to tolerance.
