BELZONA PROTECTS AND REINFORCES THE WALLS OF AN 1800 SNOW RUN-OFF TUNNEL

This 1800' tunnel is used to regulate melting snow run-off to avoid flooding in areas around the nearby mountains.

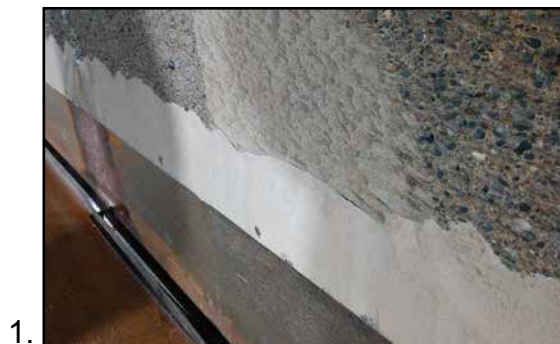
The water rushing through this 9' tunnel carries everything from silt to large boulders. This takes its toll on the concrete walls that were originally poured in 1953. In order to protect the walls, there were steel plates mounted on the lower portions, and in 2001, Belzona 4111 was applied from the top of the steel section up from 18" to 4' depending on the location inside the tunnel. After 17 years of exposure to this environment, the Belzona 4111 was starting to show some wear.

1. 17 year old Belzona 4111 (Magma-Quartz).
2. Belzona 4911 (TX Conditioner) applied.
3. New Belzona 4111 (Magma-Quartz) applied.
4. Application complete.
