## A SHOWER AT A MINE MADE SAFE WITH BELZONA

A shower room at a live-in camp at a mine in Alaska.

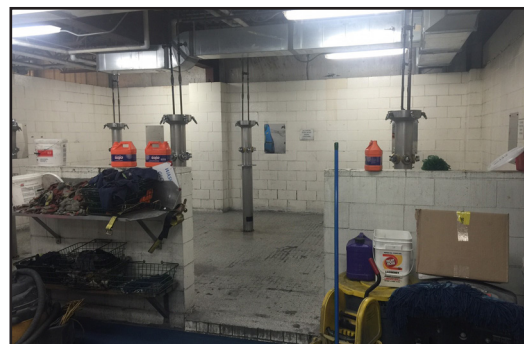
Originally, the floor was tiled. Eventually, it was damaged and an epoxy coating was used. It did not last too long before it began to flake off.

1. Shower in original condition.
2. Shower in original condition.
3. Application is complete.
4. Application is complete.
