## NEW BELZONA COATING FOR TWO SIDE-BY-SIDE CONDENSER TANKS

Two condenser tanks.

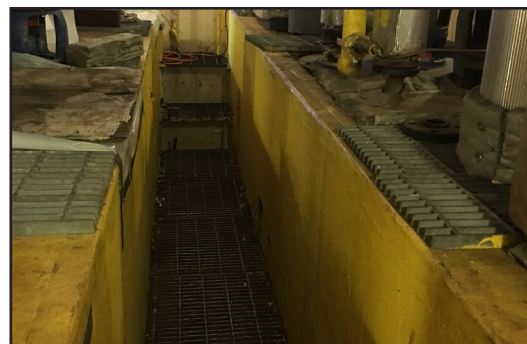
The existing coating in the tanks was having some problems with delamination. The owner wanted them to be coated with Belzona. These tanks held water around 198 F. They had no agitation.

1. Two condenser tanks, side by side.
2. Blasting the tanks using Sponge Jet.
3. Newly re-coated tanks with two coats of Belzona 5892.
4. Newly re-coated tanks with two coats of Belzona 5892.
