BELZONA SAVES A LARGE HOT WATER TANK AT A MEDICAL FACILITY

A large hot water tank, 198 F, used for bath water at a medical facility.

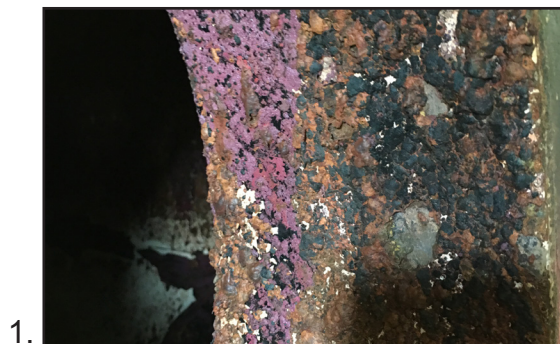
The original tank was very rusted and the original coating was mostly worn off. They didn't even know if the tank could be saved but were willing to try a new coating system. This facility has many residents and they were afraid the tank would fail and there would not be any money budgeted to get a new tank as quickly as they would need it. This was the only tank they had for this purpose.

1. Rim before Belzona restoration.
2. Inside tank before restoration.
3. Rim after restoration.
4. Inside tank during final coat.

The tank was grit blasted with Black Beauty to Belzona's standards. Then two coats of the 5892 were applied. Belzona 5892 was chosen because it could withstand high temperature and could be put back into service quickly. The application was done in accordance with a modified version of Belzona System Leaflet TCC-5.
