BELZONA GIVES A NEW LIFE TO A PAPER MILL PUMP

An old pump at a paper mill plant.

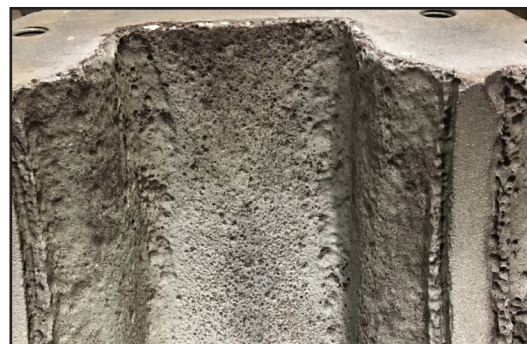
The interior of the pump metal was severely pitted and the efficiency was compromised. This pump was slated to be scrapped because it was in a bad shape. The replacement pump did not arrive in time so the decision was made to try to salvage this pump using Belzona.

1. Pitting and degradation of the pump after it was blasted with Black Beauty.
2. Before the product application.
3. The metal rebuilt and coated.
4. Two coats of Belzona 1321 applied over Belzona 1311.

Substrate was grit blasted with Black Beauty and then following the Manufacturer's Instructions for Use, a Belzona applicator was used to apply Belzona 1311 to rebuild and smooth out the damaged metal substrate. Belzona 1321 was then applied by a stiff bristle brush in two coats. The application was carried out in accordance with Belzona System Leaflets CEP-3 and CEP-5.
