BELZONA RE-COATS A LARGE GOULDS PUMP IN A PAPER MILL

A large Goulds Split Case Pump that has worked 24/7 in a paper mill for many years.

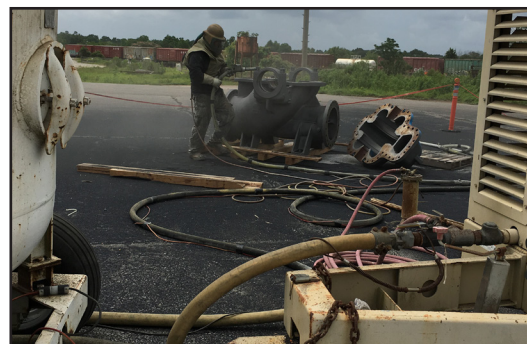
1. Blasting out in the on-house contractor's blast yard.
2. Bringing in the pump with an overhead crane.
3. Application complete.
4. Application complete.

Old coating was blasted off with Black Beauty to reach the cleanliness profile required by Belzona. Belzona 1311 was applied to smooth out all rough areas. Two coats of Belzona 1321 were applied with brushes. The application was carried out in accordance with CEP-3 and CEP-5 Belzona System Leaflets.
