BELZONA HIGH TEMPERATURE RESISTANT COATING PROTECTS TRANSITION SPOOLS AND VESSEL

Major Oil company, China/ Kazakhstan

Internals of transition spools and new vessels at a vessel fabricator in China. These transition spools were connected to the different vessels and are due to be delivered to the end-user for installation at jobsite in Kazakhstan (2019).

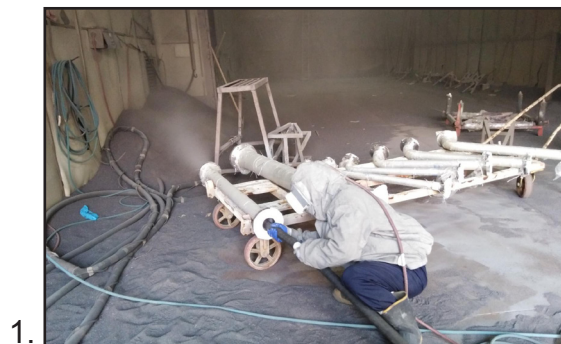
1. Grit blasting in progress.
2. 1st coat applied.
3. 2nd coat completed.
4. HVT testing.

The application was carried out in accordance with Belzona Know-How System Leaflet VPF-3. Following surface preparation by grit blasting, the Belzona 1391T was hand applied directly onto the prepared surface.
