BELZONA REBUILDS AND PROTECTS CAVITATED FAN VANES

Talkha, Egypt

October 2006

Fan vanes

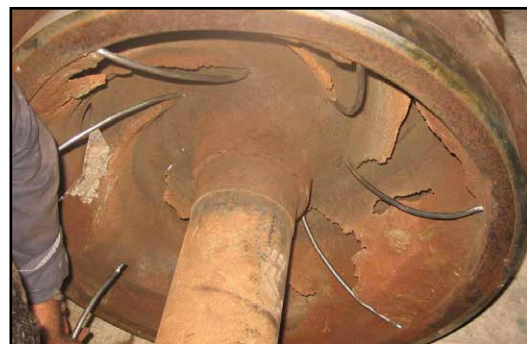
The fan blades were suffering from the effects of cavitation damage.

1. Damaged Fan Blades
2. Belzona 1311 application
3. First coat of Belzona 1321
4. Second and final coat of Belzona 1321
