BELZONA REBUILDS DAMAGED SLIDING FACE OF MILLING MACHINE

Horizontal milling machine

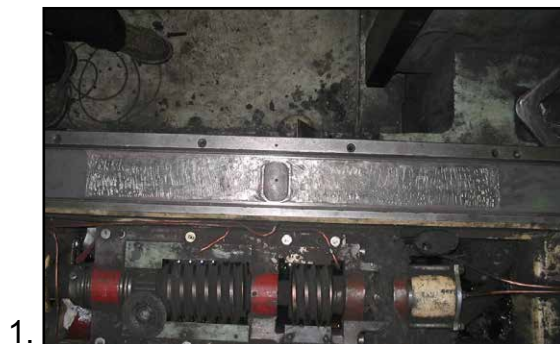
1. After surface preparation
2. Product being applied
3. Former being used.
4. Finished repair

The surface was roughened by using an angle grinder. Belzona 1111 was applied in excess before a specially fabricated was used to restore it to the original dimensions.

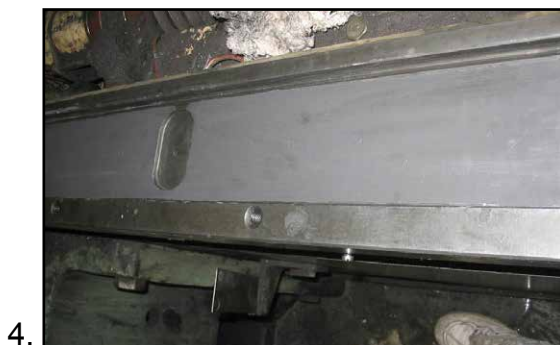
The horizontal mating face of the mill was damaged due to impact. Therefore this had to be rebuilt in order for the equipment to operate correctly.
