BELZONA SOLUTION FOR CORRODED RISER CASING

Gulf of Thailand

Offshore riser casing required a solution to extend service life

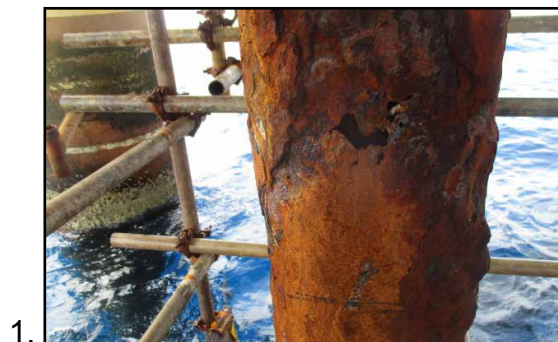
Leaked and severe corroded surfaces were observed on splash zone of riser casing.

1. Corroded riser casing
2. Rebuilding process with Belzona 1111
3. SuperWrap II Application
4. Completed Application
