## BELZONA GIVES NEW LIFE TO FAN BLADES

FRP fan blades in a petrochemical powerplant required rebuilding and coating

Deposit, erosion and mechanical damage of FRP fan blades for cooling tower were observed during turnaround period

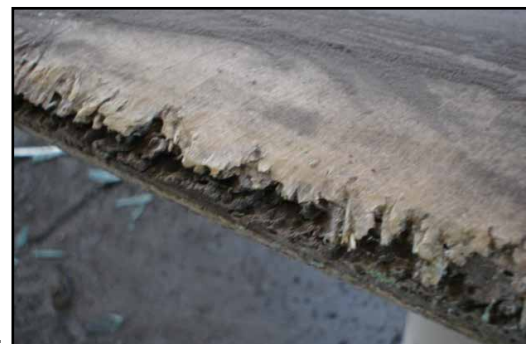
1. Leading edge damage
2. Surface preparation using power tools
3. application of Belzona 5111
4. Application of SuperWrap II
