BELZONA REPAIRS A RAW MILL IN A CEMENT INDUSTRY

Wear plates on rollers

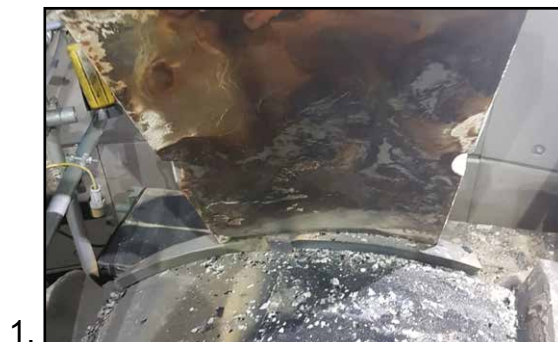
There are three rollers per mill and there are 12 wear plates (1200 kg each) per roller. The clamps are fixed with 4 large bolts. There was play between the wear plate and the roller and the bolts and clamps were failing, leading to a forced stoppage of the mill.

1. Before application
2. After surface preparation
3. After application of Belzona 1111
4. Final application
