## BELZONA STOPS STRESS CORROSION CRACKING

Production facility of an Oil & Gas company

The column was suffering from dozens of cracks due to stress corrosion cracking (SCC) and some of them were leaking.

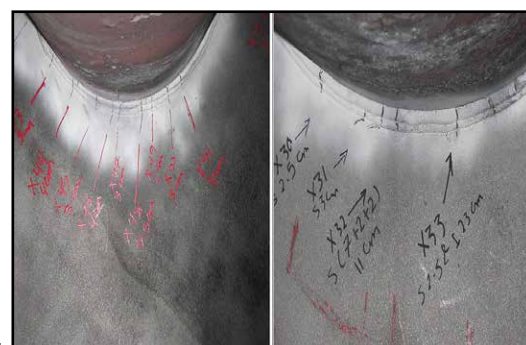
1. The site
2. The cracking
3. The completed Belzona 1591

Belzona 1591 was applied over the cracked areas to eliminate further cracks formation and Belzona 1111 was used to repair the leaking cracks from outside. Copper wire brush was the only suitable surface preparation tool due to the presence of flammable material. This application was completed in accordance with a modified version of Belzona Know-How System Leaflet TCC-01.

Hot work was not an option due to flammable material inside the column and the large number of cracks. The plan was to replace the column after 6-8 months but Belzona's performance was exceptional. It stopped the leakage and no further stress corrosion cracking was observed. The column is still in operation after 5 years.
