BELZONA FLOOR REPAIRS AT FOOD MANUFACTURER

Food Manufacturer in Northamptonshire, UK

Deteriorated concrete floor in liquor make up area

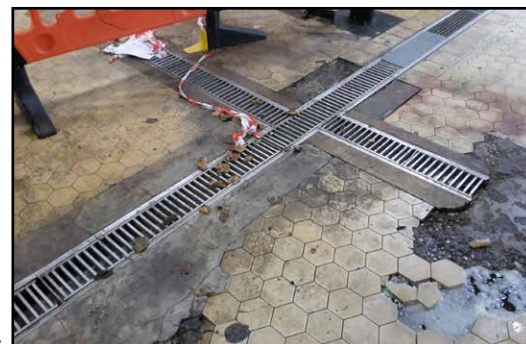
The customer had issues with the flooring where the tiles had started to lift and detach from the concrete substrate in a number of areas. The concrete was damp, wet and spalling in several areas.

1. Damaged concrete around drainage area
2. Extent of damage to floor with tiles removed
3. Belzona 4131 used to repair floor
4. Completed application
