BELZONA FILLS THE VACUUM

A vacuum pump in a chemical plant carrying sulphuric acid at elevated temperatures.

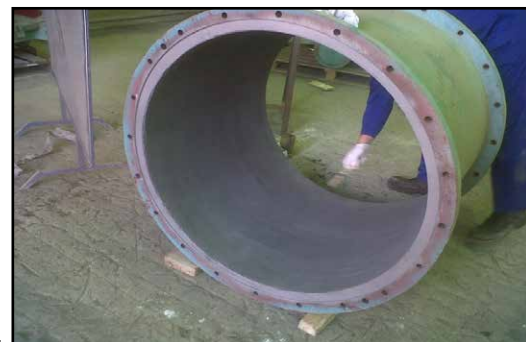
1. Internal casing after preparation
2. Internal casing after coating
3. End covers coated
4. Impeller coated

After cleaning with a solvent degreaser to remove chemical residues, the surface was grit blasted to achieve a surface cleanliness in accordance with Swedish Standard SA 2.5 "Near White Metal". The entire internal surface, end covers, and impeller were coated with 2 layers of Belzona 4341. On the impeller tips, the coating was rebuilt to an excess of 5mm, then machined back to the required tolerances. The application was carried out in accordance with a modified version of Belzona Know-How System Leaflet CEP-03 & CEP-07.
