## BELZONA REPAIRS A WATER SLIDE IN AN AMUSEMENT PARK

Expansion joints on a water slide

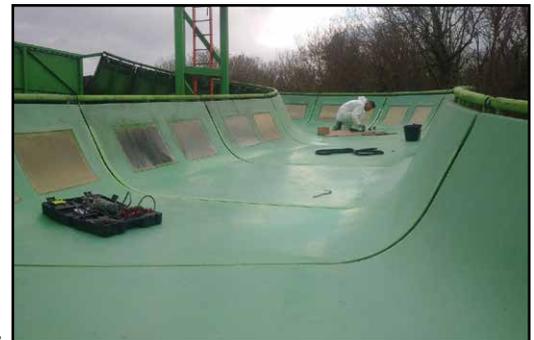
1. Overview of the slide
2. Previous joints removed
3. Application of the elastomers
4. Zoom on the finished repair

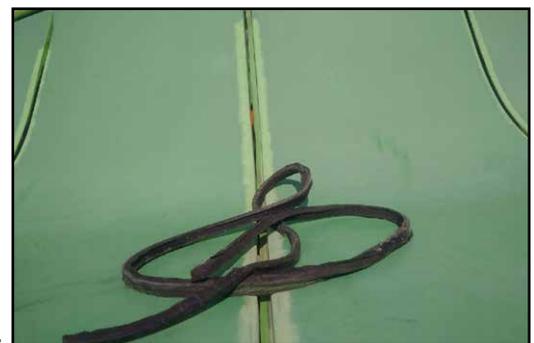
2.

The expansion joints were badly damaged by the rubber rings used on the slide. This was causing water infiltration in the little tunnel underneath the slide where customers can walk.

The previous expansion joints were removed, the substrate was manually abraded and the conditioner was applied. Then a foam rod was used at the bottom of the slot and Belzona 2121 was poured on top on the horizontal sections. Belzona 2111 was used for the vertical and curved sections. An applicator was then used to smoothen the surface of the elastomer and make sure that the joints were at the same level as the surface of the slide so the rubber rings would not damage it and the slot edges would not damage the rubber rings. This application has been carried out according to Belzona System Leaflet FPA-6.
