## BELZONA OPTIMIZES THE EFFICIENCY OF A DISTRIBUTION CHAMBER

Steel and concrete surfaces of a distribution chamber.

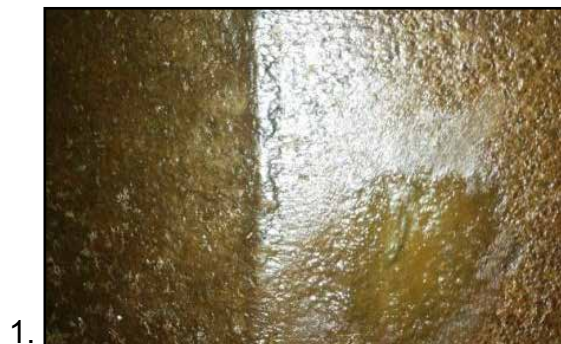
Due to an important flowrate of water from the river nearby, the surface of this distribution chamber, which had not been protected before, was badly damaged and needed to be rebuilt. The sharp angles of the concrete inside the chamber cause a resistance to the water flow, besides, the steel surface is badly corroded.

1. Sharp angle on the concrete
2. Reconstruction of concrete
3. Application of Belzona 1341
4. Final application
