## BELZONA SEALS DILUTED ACID LEAK

A sulphuric acid scrubber in an acid plant subject to contact with diluted sulphuric acid.

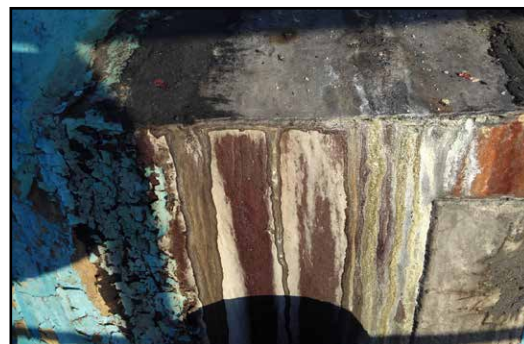
A small leak had developed at the top section of the scrubber. The resulting leak dripped down onto a lower area of the surface, causing damage to the external coating and resulting in an additional leak.

1. Leak caused by internal chemical attack
2. Damage caused by dripping acid
3. Surface preparation complete
4. Application complete
