## BELZONA RESTORES SULPHURIC ACID TANKS

Sulphuric acid storage vessel.

Strong corrosion of the steel structure of the installation and the sulphuric acid storage vessel required restoration.

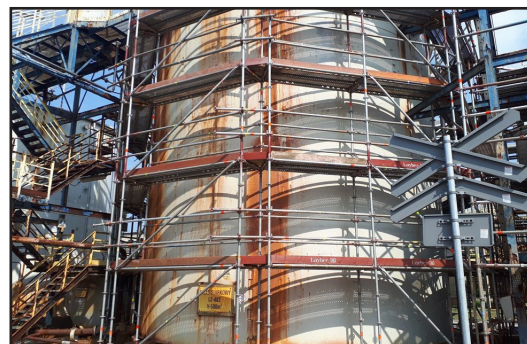
1. The original state of the tank.
2. The structure after blasting.
3. The structure after coating with Belzona 5811 and Belzona 5111.
4. The first completed tank, compared to the unrestored tanks.
