## HYDROELECTRIC GENERATING STATION SCROLL TUNNEL

Hydroelectric power station, Alabama, USA

Refurbishment of a Hydro electric Generating Station to allow the facility to be brought back online.

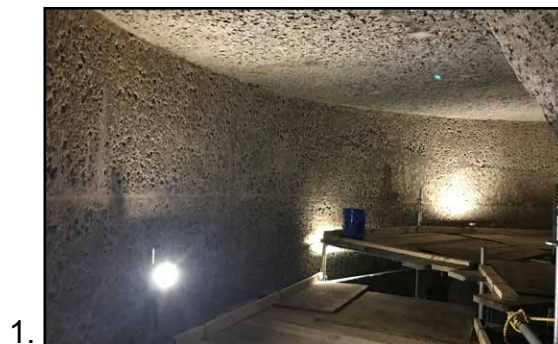
The concrete scroll tunnel walls, floor, and ceiling were deteriorating due to many years of operation. Total area to be treated was 9000 ft<sup>2</sup>. Belzona 4141 lightweight Magma Build was used to restore the ceilings up to 2" thick in areas. The walls and floor were repaired with Belzona 4131. After restoring the concrete, Belzona 5811 barrier coating was used protect the entire area .

1. Concrete deterioration
2. Rebuilding concrete with 4131
3. Tunnel coated with 5811
4. Finished results
