BELZONA REPAIRS GEAR BOX BEARING HOUSING

Gear box bearing housing.

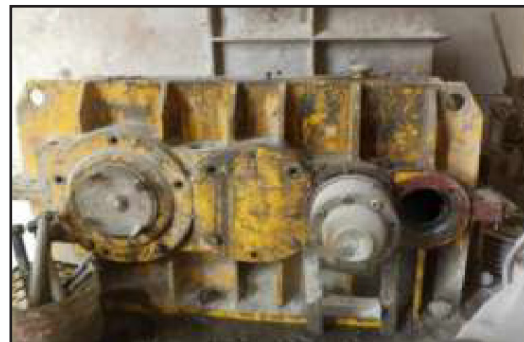
1. The gearbox.
2. The damaged surface.
3. The repair underway.
4. Application completed.
