BELZONA PROTECTS PLATFORM SEAWATER CAISSON

Seawater caisson, an oil platform.

Inspection of a seawater caisson revealed defects, requiring a section to be replaced.

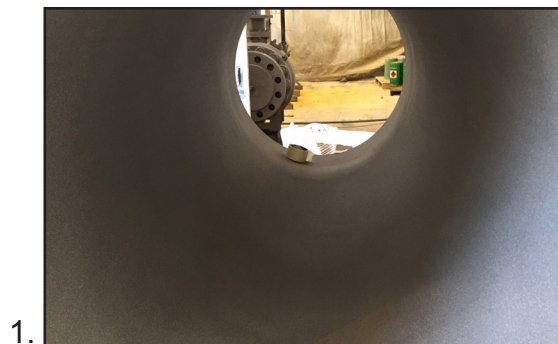
1. Caisson after grit blasting.
2. Measuring Average dry film thickness (DFT).
3. Completed application.
4. Bottom of caisson section protected.

New caisson section was fabricated for replacement and was grit blasted to SA 2.5 before being coated with Belzona 1391S. The application was carried out in accordance with a modified version of Belzona Know-How System Leaflet VPF-2.
