## BELZONA SUPERWRAP II REPAIR OF REFINERY PIPE

6" pipe carrying produced water and methanol.

Customer reported a through wall defect in a 6" pipe. Production was severely limited because of the leak, so the customer needed a repair carried out urgently.

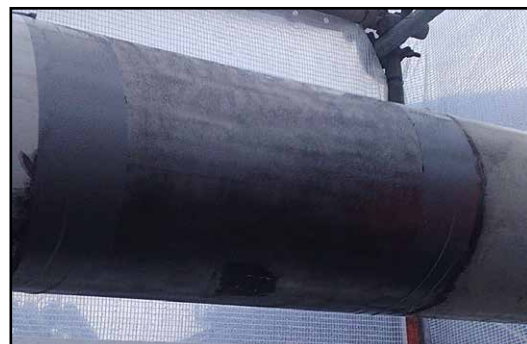
1. Plated bonded with Belzona 1212
2. Application of consolidation tape
3. View of the finished Superwrap II application
4. Another view of the finished Superwrap II application

A 20x20mm pre-fabricated plate was bonded into position followed by the Belzona Superwrap II system. The application was completed in accordance with Belzona Know-How System Leaflet VPF-11 following the Belzona Superwrap II design.
