BELZONA 1812 IN USE AT PEAT POWER PLANT

Estonia

2018

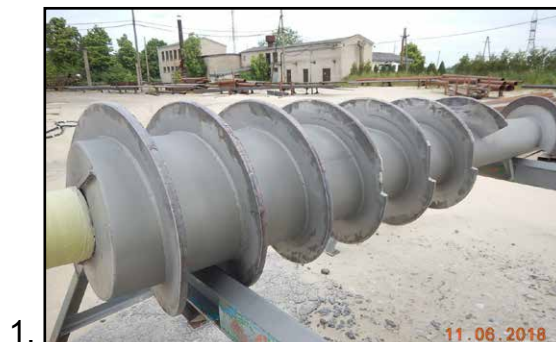
The customer's drawing shows that the screw tube must be welded with a hard facing CASTOLIN 5006. Screw was used for transporting peat.

It is very time consuming and costly for the client. Welding would make the pipe fragile and very difficult to use post-process.

1. Screw before Belzona coating
2. Screw complete with Belzona coating

Application was carried out in accordance with Belzona Know-How System Leaflet SHM-14. Grit blasting was used to prepare the surface, followed by a lining of Belzona 1812
