## CORROSION PROTECTION OF TWO INDUSTRIAL STORAGE TANKS WITH BELZONA 5811

Corrosion protection for 2 DEMI water tanks (Total area - 1520 m<sup>2</sup>, 2000 m<sup>3</sup>)

Corrosion on the internal linings of two large storage tanks at a large industrial plant in Poland.

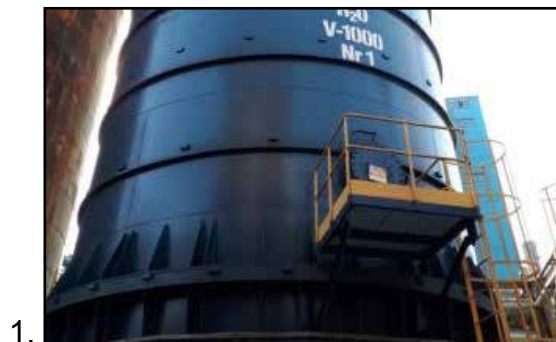
1. One of the storage tanks to be coated
2. Belzona 5811 applied internally
3. Testing coverage
4. Application complete on the internal lining
