## BELZONA SEALS RIVET TANK

Sealing the base of a rivet tank to protect it against corrosion.

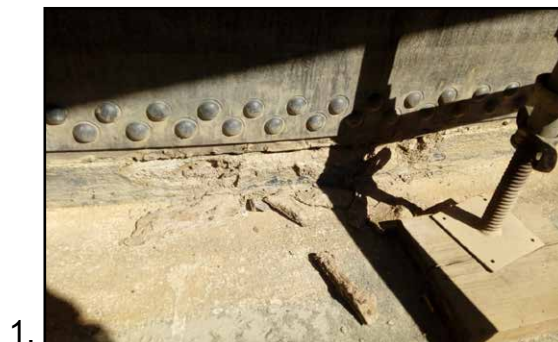
An existing coating had failed at the base of a rivet tank and degraded due to UV exposure. With the tank base unprotected moisture ingress was able to shoot underneath the tank as the tank expanded and contracted causing further corrosion.

1. Deteriorated base
2. Belzona 4111 chamfer angle
3. Belzona 5811 + 3111 first coat
4. Finished application
