## BELZONA MAGMA FOUNDATIONS REPAIR AT CEMENT FACTORY

Repair of the foundations of the clinker furnace head at a large cement factory in Poland.

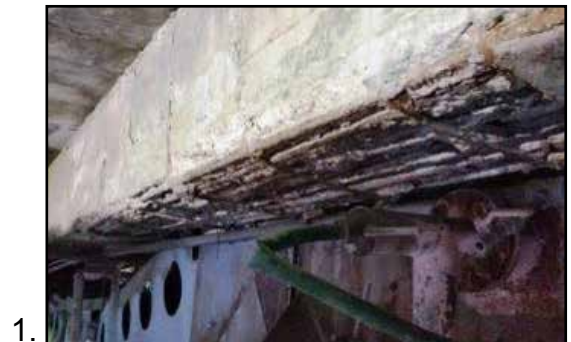
During long-term operation under varying climatic conditions and high temperatures, the foundation (supports, beams) was degraded under the head of the clinker furnace.

1. Degraded Concrete
2. Metal Mould to pour Belzona 4111
3. Applying Belzona 4111
4. Finished Job.
