CHEMICAL PROTECTION OF A SEDIMENT TANK

Chemical protection of the sediment tank and reinforcement in the sewage treatment plant with Belzona composite materials.

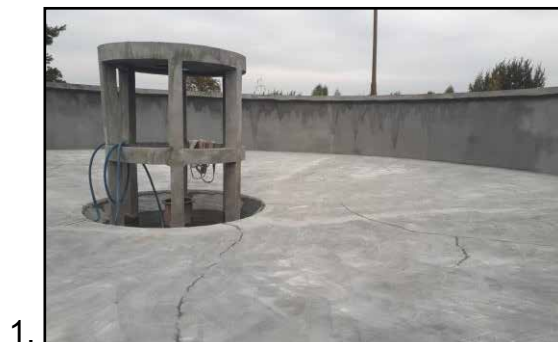
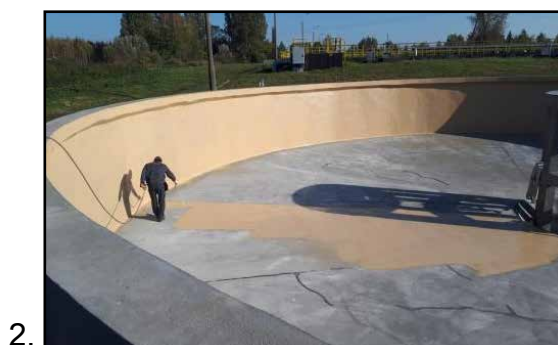
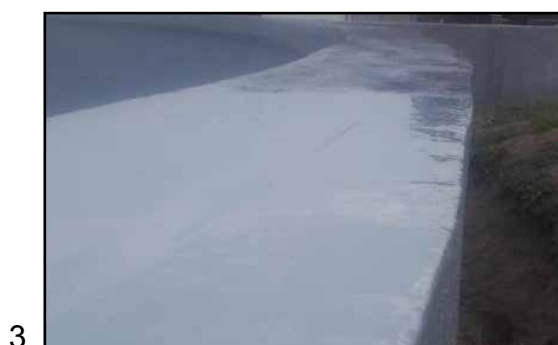
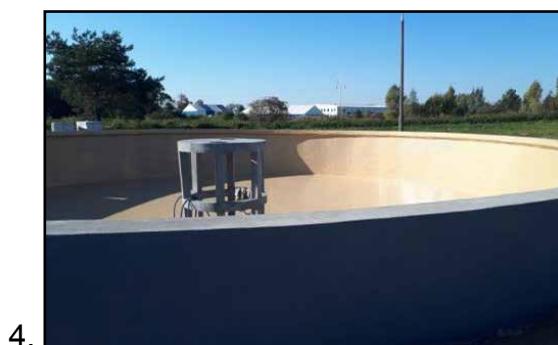
1. Chemical Protection
2. Spraying Picture
3. Applying Picture
4. Application Complete

The accumulation of sediment on the bottom and walls of the tank. The penetration of aggressive dirt into the depths of concrete, chemical corrosion of concrete and damage to concrete walls of the tank and cracking at the bottom.

The application was completed in accordance with Belzona Know-How System Leaflet TCC-15. High pressure washing, blast-cleaning and vacuum cleaning of the interior of the entire tank. Surface activation and re-profiling of the side wall defects and cracking of the sediment bottom with the Belzona 4111. Applying two layers of the Belzona 5821 coating by airless spraying.
