HOT ORE NO PROBLEM FOR BELZONA

Aluminium Plant - Spain

March 2018

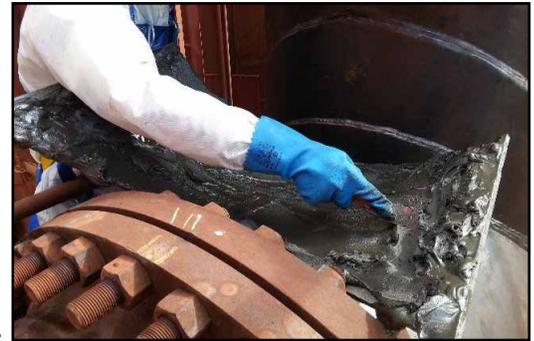
1. Belzona 1251 being applied to reinforcement plate
2. Reinforcement plate bonded into place
3. Belzona 1511 used to create a fillet around the plate
4. Completed repair after wrapping with Belzona SuperWrap II

The application was carried in accordance a modified version of Belzona Know-How System Leaflet VPF-11. A carbon steel reinforcement plate was pre-fabricated to fit the worn area of the pipe section. Preparation was carried out by grit blasting to achieve a near white metal finish and a surface profile depth greater than 75 microns. The reinforcement plate was bonded using Belzona 1251 to bond onto the hot substrate whilst in service. The edges were sealed and finished with Belzona 1511 to create a smooth surface for the Belzona SuperWrap II system to be applied over. Belzona SuperWrap II with Belzona 1983 resin was used to encapsulate the area, adding further strength to the overall system.
