STRENGTHENING OF A STORAGE TANK WITH BELZONA SUPERWRAP II

Storage Tank shell deterioration and the wall of the tank thinning. Restoration of stiffness and nominal strength of the tank's shell.

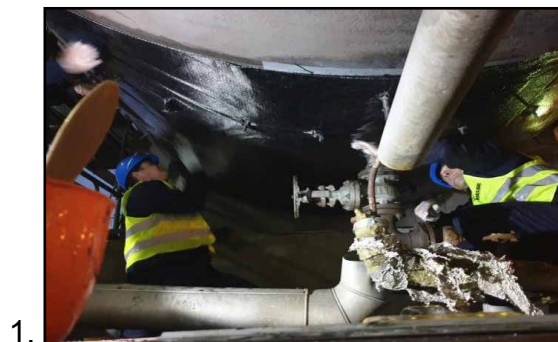
1. Belzona 9381 Superwrap II Applied
2. Belzona 9382 Release Film Applied
3. Belzona 9382 Release Film Applied
4. Belzona Superwrap II Complete

The application was completed in accordance with Belzona Know-How System Leaflet VPF-11. The substrate was prepared and degreased. Belzona 9381 Reinforcement Sheet was wet out with the Belzona 1981 resins as well as the substrate. Belzona 9382 was applied to consolidate the repair.
