BELZONA REPAIRS AND PROTECTS CORRODED EXHIBITION SUPPORTS

Museum, Bristol, UK

September, 2015

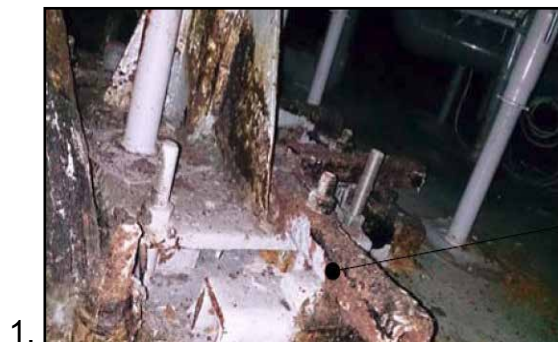
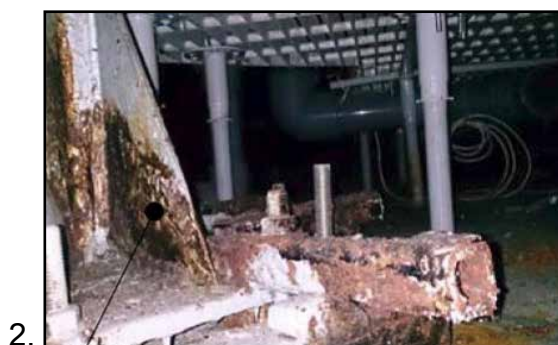
During the life of the exhibition, the metal support structure underneath the exhibition was heavily corroded by the oxidising nature of the Bromine Water. The museum were concerned about the corrosion and thus the decreasing strength of the supports.

1. Supports before application
2. Supports before application
3. Application of 5811 underway
4. Finished application showing close colour match achieved with Belzona 5111

Application was carried out in accordance with Belzona Know-How System Leaflet TCC-5. The corroded metal structure was blasted back to bare metal using sponge blasting as the client was concerned about the dust created by using regular grit blasting. Areas that were especially corroded and damaged were rebuilt using Belzona 1111. Belzona 5811 was applied with a top coat of Belzona 5111 to protect against oxidation and provide a good colour match.
