## GALVANIC CORROSION ON A FLANGE SOLVED BY BELZONA

Internal equipment of a naval vessel carrying sea water for the cooling system.

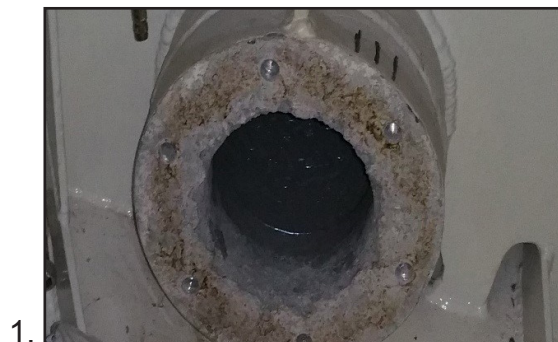
Dissimilar metals were used for the flange connection, leading to galvanic corrosion.

1. Corroded flange.
2. Surface preparation complete.
3. Rebuilding with Belzona 1161.
4. Coated with Belzona 5831.
