BELZONA RECTIFIES SAFETY ISSUES AT A LARGE FOOTBALL STADIUM

Cracks and safety issues in concrete floors

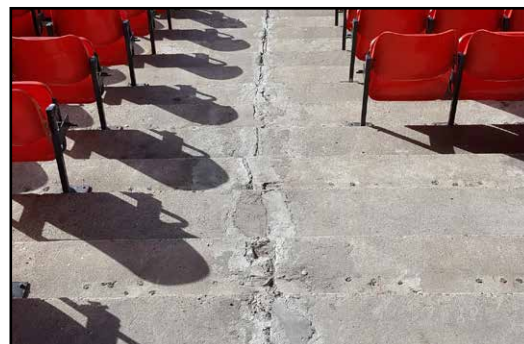
A large crack running vertically and horizontally down the step treads on the terrace stand. The damage had been caused by adjoining concrete slabs at different heights. Previous repairs had been carried out using cementitious materials, but each time they had failed. A concrete landing area also required repair as the concrete had cracked and its original grip system had worn away causing a significant safety hazard to pedestrians.

1. Concrete treads prior to Belzona repair
2. Damaged concrete removed
3. Concrete rebuilt
4. Slip resistant system applied
