## BELZONA REBUILDS AND PROTECTS A CLARIFIER

Concrete roller track, metallic turbines and floats of a clarifier.

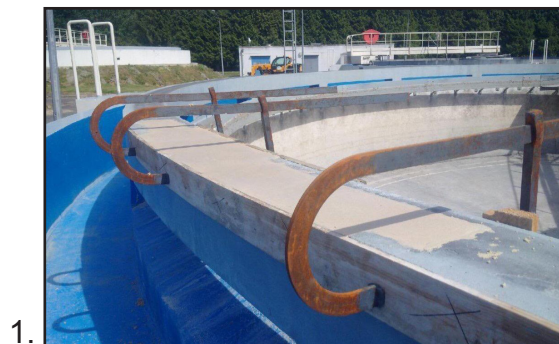
1. Concrete repair on the roller track with Belzona 4111 and a former.
2. Protection of the tripods, turbines and floats with Belzona 5811.
3. Final application.
4. Close up view of final application.

The broken parts of concrete on the roller track were taken away and the surface of both the track and the clarifier trough were prepared by scarification. Metal components were prepared by grit blasting. After the surface preparation, the concrete was rebuilt using Belzona 4111 with a trowel and a former when needed, in accordance with a modified version of Belzona Know-How System Leaflet TCC-09. The trough next to the roller track was protected with Belzona 5111. The floats and turbines were protected with Belzona 5811.
