BELZONA SAVES TANK FROM DEMOLITION

A nuclear power plant's carbon steel holding tank near the sea.

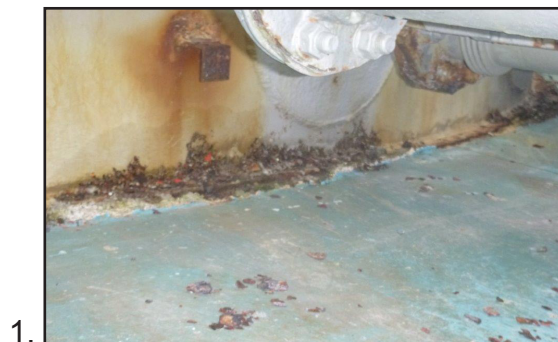
Tank has badly corroded annular plate with suspect under thickness tank base plate due to atmospheric pollutants running down the tank walls and under the plate causing external corrosion. Also, the concrete plinth has cracked and has corrosion causing some spalling.

1. Condition of concrete plinth and tank base
2. Application of Belzona 3111 in grey
3. Corroded flanges
4. Application of Belzona 341

The concrete was cleaned. The cracks and defects were rebuilt with Belzona 4111 and Belzona 4911 system. The annular plate was sweep blasted and cleaned prior to applying Belzona 3111 around the tank base in accordance with a modified version of Belzona Know-How System Leaflet GSS-3. The corroded pipe and flanges were removed and new ones were installed. The new flanges were then encapsulated with Belzona 3412 in accordance with a modified version of Belzona Know-How System Leaflet VPF-13.
