BELZONA 1812 APPLIED INSIDE SMALL-DIAMETER PIPES

Mineral mine piping system.

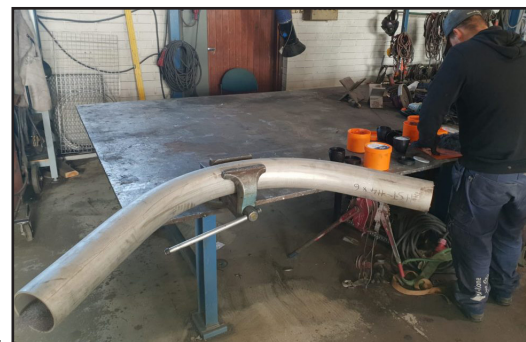
Hard abrasion from rock and mineral dust wore out long pipes with small orifice-diameters which led to a long downtime. Repairs and new installations were often required.

1. The pipe to be repaired
2. The application of Belzona 1812 underway
3. Application complete before dressing back
