BELZONA REPAIRS BALL MILL FOUNDATIONS AT A GOLD MINE

Concrete ball mill foundations.

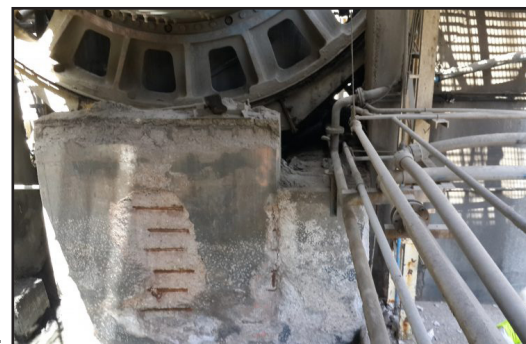
The concrete ball mill foundations degraded over time due to vibrations and warm environment.

1. Before application
2. During the application
3. Final application
4. Overview of the equipment

The substrate was first prepared by grit blasting prior to the installation of steel reinforcement bars. Belzona 4911 was then applied on the whole surface followed by Belzona 4131. The application was carried out in accordance with a modified version of Belzona Know-How System Leaflets FPA-1 and FPA-3.
