BELZONA COATS SIX CHILLERS AT AN AIRPORT

6 chillers at an international airport.

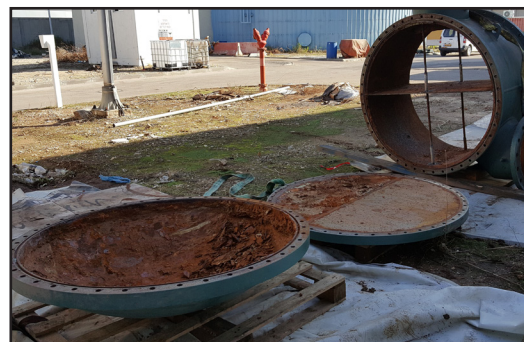
Maintenance service of an International airport experienced problem with six chillers that covered all cooling needs for the entire facility. All units were in service for the period from 5 to 10 years and suffered from extensive corrosion on covers and water boxes, that also led to gas losses and leaks through tube sheets on two units out of six.

1. One of the units in its original state
2. Rubber corks inserted before blasting on a heavy corroded tubesheet
3. Application of the Belzona system
4. Complete repair and a final coat of Belzona 1331
