## BELZONA PROTECTS 6 PUMP IMPELLERS AGAINST CAVITATION DAMAGE

6 Centrifugal Pump Impellers at an O&M company.

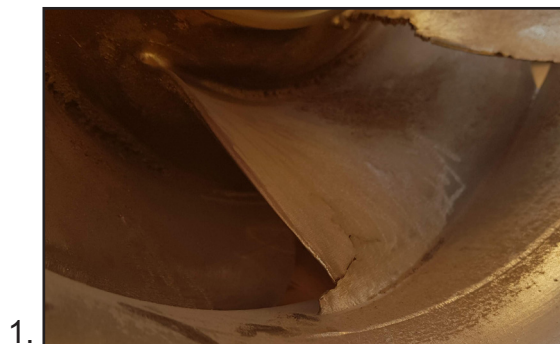
Impeller veins were experiencing cavitation which was reducing wall thickness and leading to through-wall defects.

1. Damage beforehand
2. Application in progress
3. Completed pump
