BELZONA SAVES RUPTURED EFFLUENT TANK

A large food production facility which produces ready-meals for a very prestigious high street retailer. The plant operates 7 days a week, 51 weeks a year and stopping production is not an option.

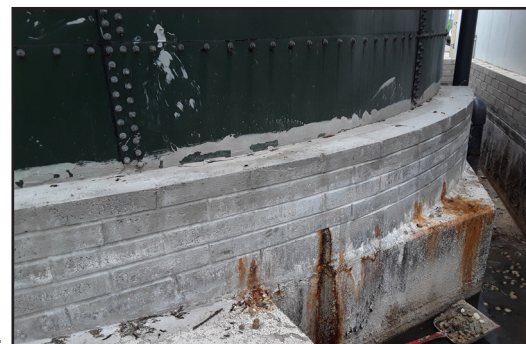
1. Before the wall came down
2. The ruptured area
3. SWII plates bonded in place
4. Finished application

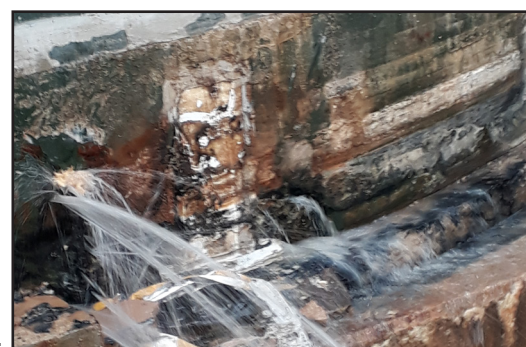
2.

The problem that the customer had was that the effluent treatment tank had multiple leaks, both into the surrounding soil, and into a bund. To avoid both hefty fines and a full tank failure, they had to find a way to repair the tank but without hindering their production. This grave situation was compounded by the fact that the tank was set on a hill within the production facility premises, but about 100 metres overlooking a large retail park. Should the tank have had a catastrophic failure when we removed the wall, 200+ tons of food waste effluent would have poured into the shopping centre, effectively shutting the whole area down.

First all the holes and cracks were plugged with wooden wedges to stem the flow. Then the areas around them were patched with Belzona 9611. Applied in accordance with a modified version of Belzona Know-How System Leaflet VPF-11. As this cured, another piece was placed over this piece, moving slowly around the splits and holes until they became virtually sealed. The wooden wedges were then sawed off as close to the tank as possible. Next, a manufactured "top-hat" was drilled and tapped, and bonded over one of the entire failed areas with Belzona 1111, encompassing all the splits and leaks in that area. The tapped "top-hat" meant that the small leaks had a means of escape whilst the Belzona 1111 was curing. Finally, when the Belzona 1111 cured a bolt was screwed in, sealing the leaks. An area to the right of the "top-hat" was patched using a large sheet of Belzona Superwrap II. Finally, Belzona 1111 was applied as a 75mm band around the base of the tank, incorporating reinforcement sheets, to seal the multiple leaks around the base.
