## BELZONA PROVIDES EROSION PROTECTION ON EXHAUST FAN

Eroded fan blades at a cement plant.

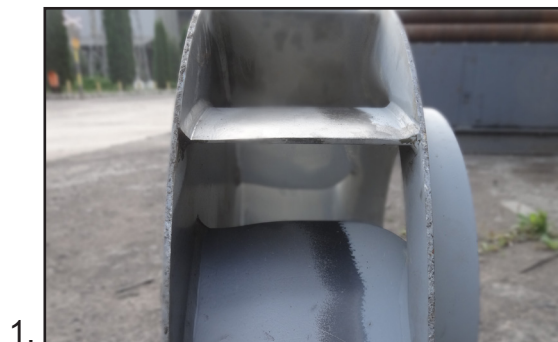
The dry air (70°C) carrying Al, Si, MgO, CaO dust erodes the vanes of the fan blades, removing 2.5-3 mm thickness from the metal.

1. The eroded fan
2. The fan after surface preparation
3. The leading faces of the fan blades rebuilt with Belzona 1812
4. The leading faces of the fan blades coated with Belzona 1321
